Manhole Inspection Summary

Manhole # S55K__045MH

Location Address: **803 s eaton ave**

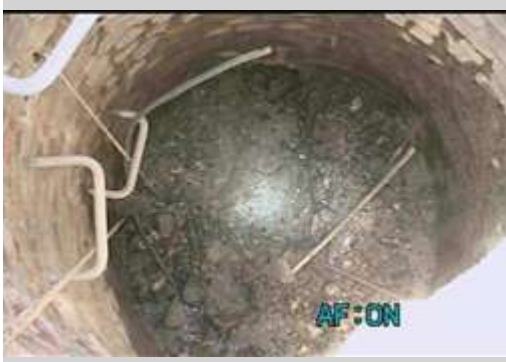
Defect 2

Condition: ☐ Sound ☐ Cracked ☐ Root Intrusion ☐ Deteriorated ☐ Leaks ☒ **Debris**

debris

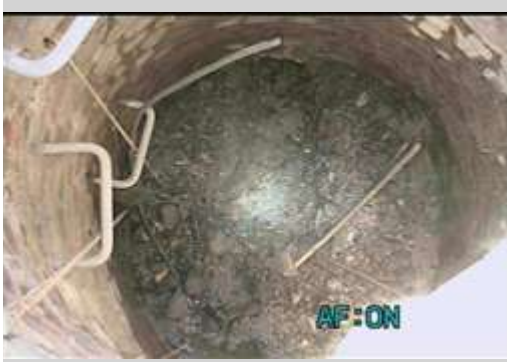
Defect 1

Steps Count: **3** Missing: **0** ☒ **Corroded**

Corroded steps

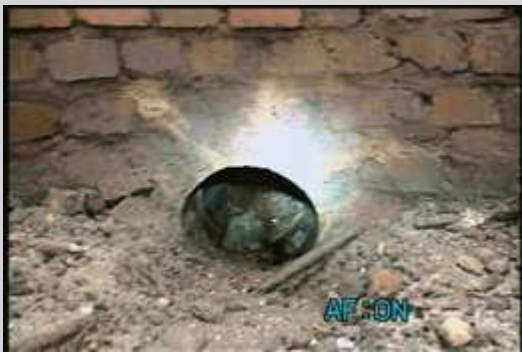
12 O'Clock Outflow

8 in. Circular Gravity Sewer
Pipe Out @ 12 O'Clock

Deposits: ☒ None ☐ Mud ☐ Sludge ☐ Debris ☐ Grease

Infiltration: **None** Pipe Seal Cond: **Unknown**
